Flaretite Seal

Performance Evaluation Test Results

R-22 Refrigerants

ASADA CORPORATION

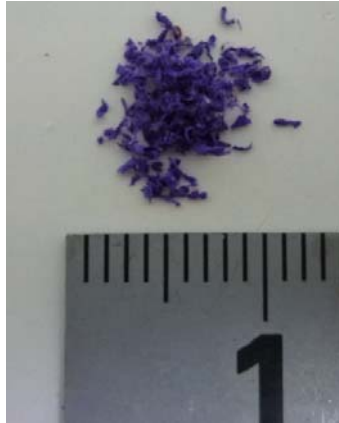
Cutting scraps of Flaretite

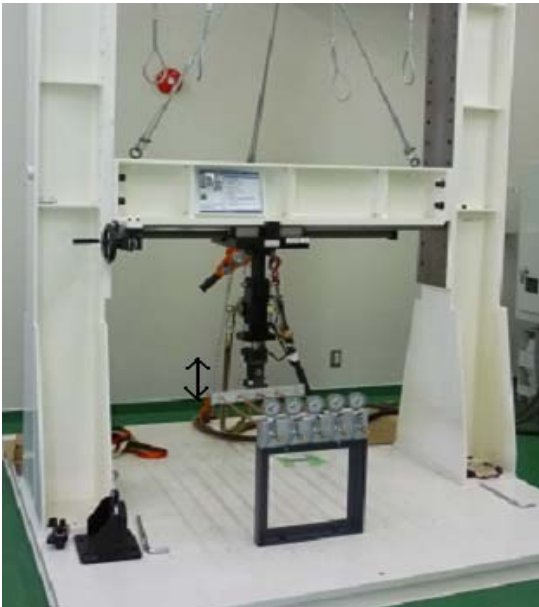
Initial time point

No leak and no malfunction were observed in flare joints. When the test was completed, the pressure of the gauge was the same as the pressure when the test was started.

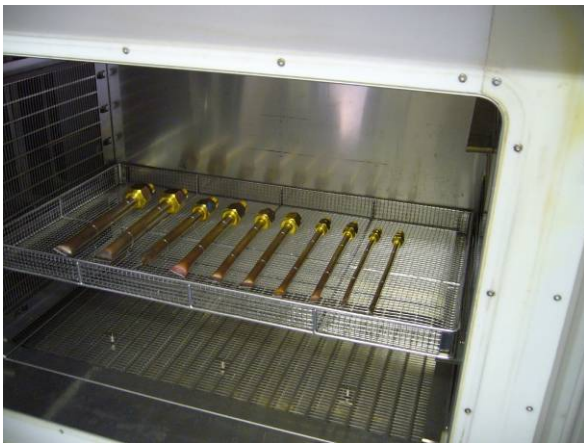
第 293 号
 成 績 書
 平成 24 年 7 月 2 日
 依頼者 アサダ 株式会社
 依頼事項 冷熱衝撃試験
 記 事 試料名 フレアタイト 接合サンプル
 (1/4×2本, 3/8×2本, 1/2×2本, 5/8×2本, 3/4×2本)
 試験装置 エスベック株式会社製
 冷熱衝撃装置 TSA-100D-W
 試験装置シリアルNo: 3290900067
 試験装置設定内容
 高温さらし温度 +120℃
 低温さらし温度 -40℃
 さらし時間 (高温・低温共) 各 60 分
 試験サイクル数 100 回
 (低温側より開始)
 試験日 平成 24 年 6 月 20 日~6 月 29 日
 試験場所 名古屋市工業研究所 環状試験室
 以上の条件にて試験を実施しました。
 名古屋市工業研究所 名古屋市工業研究所
 所長 廣田 幸弘

Expose Flaretite Seals to temperatures of both +120 and -40 degrees Celsius each 1 hour alternately and repeat this 100 times then leave Flaretite Seal on normal temperature. Inject N2 to 4.1MPa and leave the test pieces for 1 hour. Then check if a leak is observed.

Test piece	No.1					No.2				
Size	1/4"	3/8"	1/2"	5/8"	3/4"	1/4"	3/8"	1/2"	5/8"	3/4"
Leak	No	No	No	No	No	No	No	No	No	No

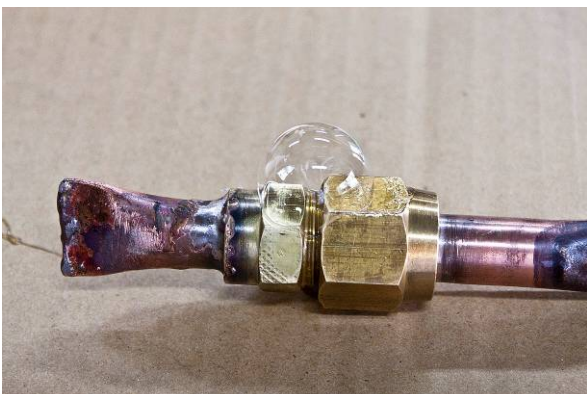
Before installing

Confirm the leak before installing Flaretite Seal and no leak after installing Flaretite Seal. No pressure decrease was observed 2 hours later.
