Flaretite Seals Solve Nuclear Problem

Application: Flaretite Seals

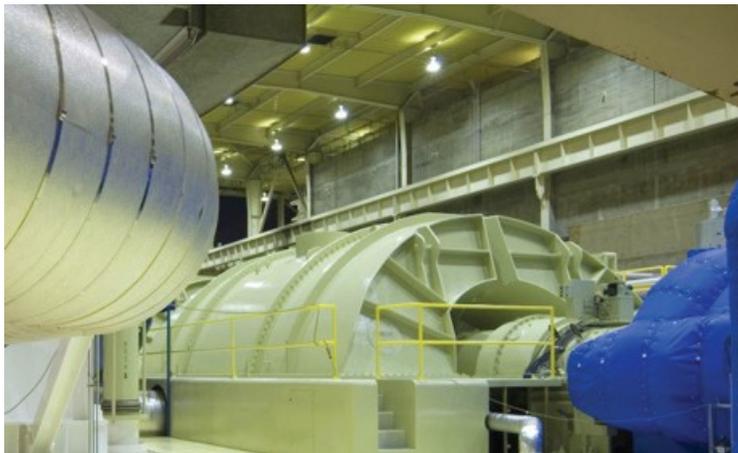
Steam Turbine

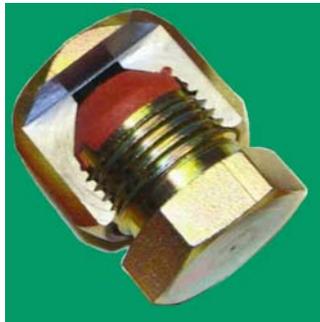
Cut-a-way

Flaretite Seals are unique seals. They are stamped from stainless steel or copper with patented sealing ribs around the sealing face. When the seal is installed in a standard fitting and the fitting is tightened, the sealing ribs are compressed. Each independent rib acts similar to a lock washer on a nut and bolt, maintaining constant pressure on the sealing faces. During times of high vibration and large temperature cycles, this pressure insures that the fitting remains leak-free. Most seals are also coated with a Loctite coating, which adds a second level of protection to the seal design.

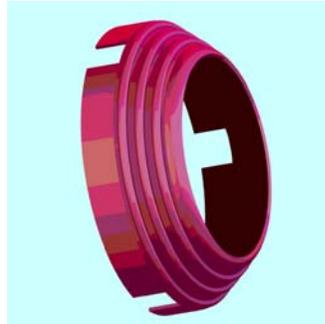
Flaretite Seal

Sealing Ribs with Loctite coating

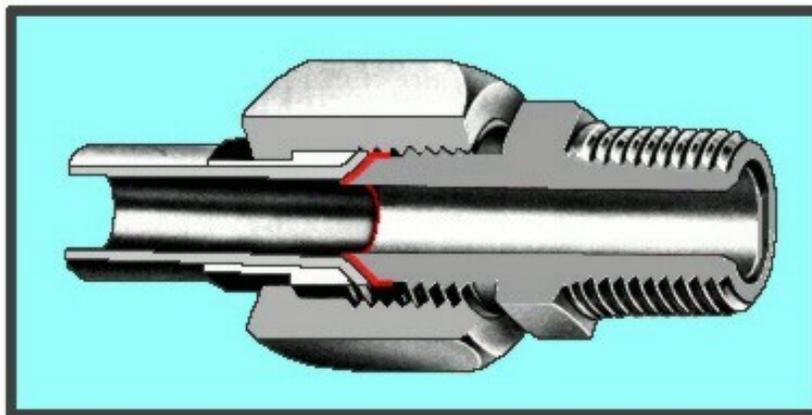
Flare fitting with Flaretite Seal installed

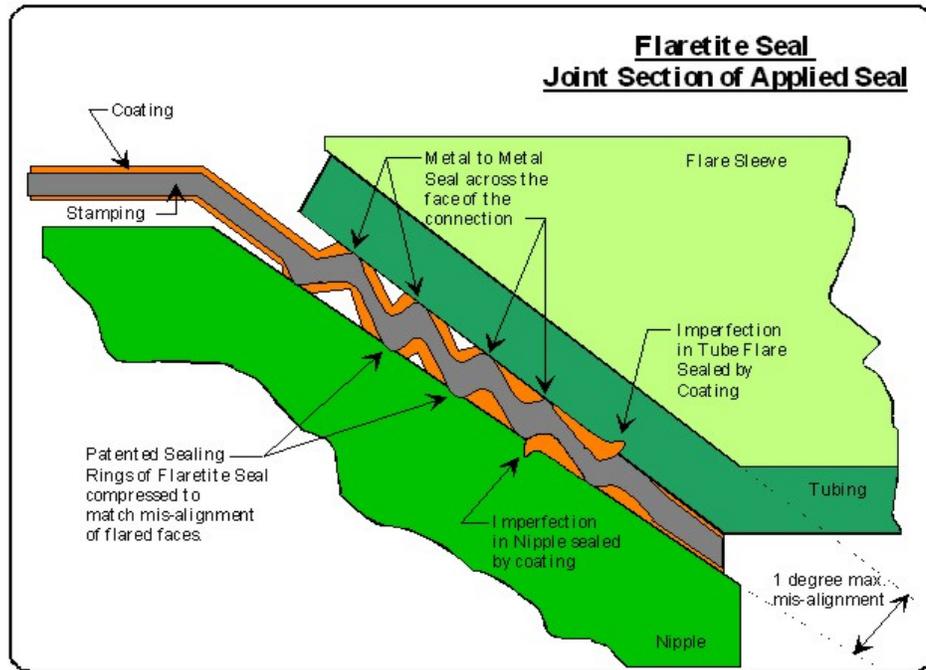
Section View of Seal after installation

The Flaretite Seals were ordered and arrived the next day. They spent the next two days breaking loose all the connections and installing the Flaretite Seals. To further insure that each seal was properly installed, open ended Torqtite Wrenches were utilized to tighten all the various sized fittings to the exact fitting manufacturer’s torque recommendation.

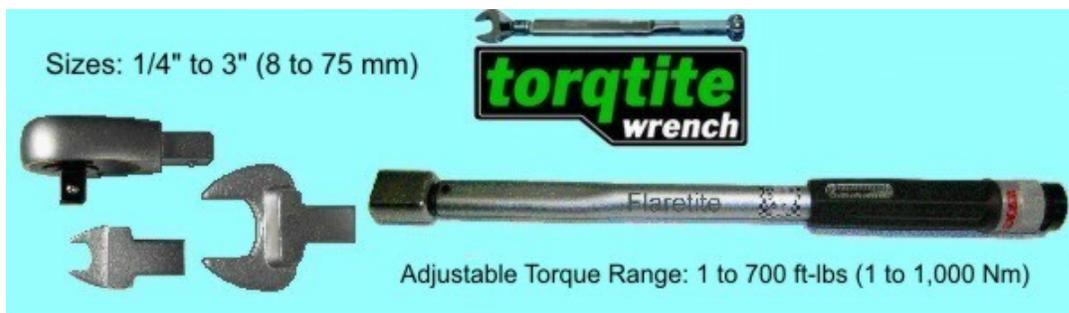
The Torqtite wrench removes these technical problems by offering a truly “open-ended” torque wrench style which regulates the applied torque to each fitting. Recommended torque values are listed for each style of fitting to insure that the fitting is properly assembled. To add versatility, the torque value of each wrench can be adjusted, and the “open-ended” attachment is interchangeable with other hex sizes.
